**MARINE INVESTIGATION REPORT**  
**M01C0029**

**SWAMPING AND CAPSIZING**

**FISHING VESSELS *SHANNON DAWN* AND *RACHEL M***  
**LAKE WINNIPEG, MANITOBA**

**15 JUNE 2001**

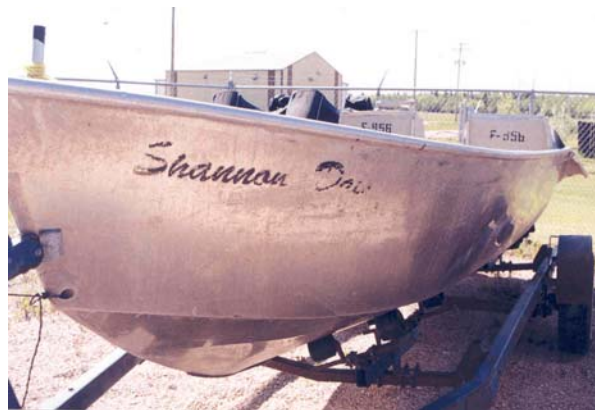
**Photo 1.** Port bow view of *Shannon Dawn*

The *Shannon Dawn* was of an earlier Lake Winnipeg yawl hull design. The vessel was fitted with a sealed buoyant compartment below deck level. Some newer models, as well as some older models, have been fitted or retrofitted with more flotation tanks for additional buoyancy, and with an increased forward freeboard for improved sea-keeping ability. The development of this hull design now provides for two additional modifications to reduce the shipping of water on deck. The inboard coaming around the motor well at the transom has been raised, and the forward sheer of the hull from midships has been increased.

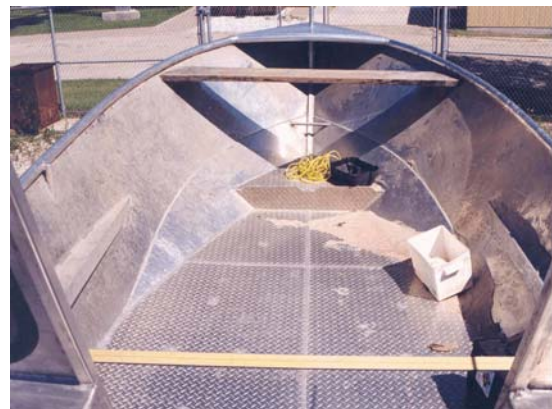
The *Rachel M* had these modifications incorporated in its hull. Since both small fishing vessels were less than 15 gross tons, neither vessel was required to be inspected by Transport Canada.

Photo 2. *Rachel M* – Larger sheer at bow

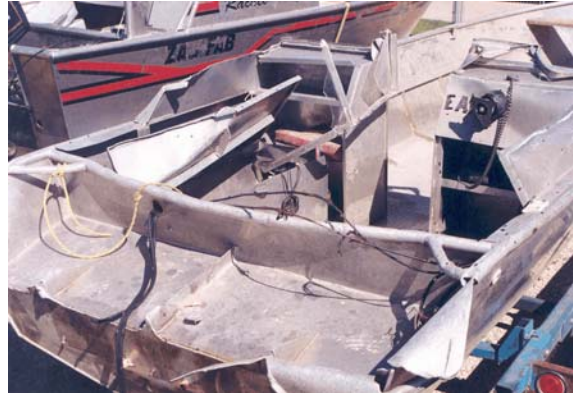
The *Shannon Dawn* was discovered almost submerged, approximately four miles south-southwest of the location of the *Rachel M* and one nautical mile beyond the shoals in deeper water. The bow of the vessel was projecting above the surface of the water. The outboard motor

had been ripped off the transom. The motor was not recovered. The remainder of the vessel had extensive damage to the windshield, split steering console and motor bracket. The bilge pump, which was reported to have been non-operational before the occurrence, was missing.

The *Shannon Dawn* was found with the tip of the bow projecting above the surface of the water, which tends to support a “capsizing settling by the stern” scenario. When the vessel was recovered, it was missing its motor. It is suspected that the motor was ripped off the transom when the *Shannon Dawn* passed over the first set of shoals at the southwestern tip of Berens Island. The vessel then drifted approximately one mile further. Any ingress of large volumes of water would create a dangerous “free-surface effect” and significantly reduce the *Shannon Dawn’s* stability. The bilge pump was missing and had been reported as being non-operational. Consequently, shipped water could not be discharged from the vessel. In the heavy rolling sea with cresting waves, the free-surface effect of the entrapped water on board would have contributed to the capsizing action.

Photo 3. Damaged *Shannon Dawn*

4. The *Shannon Dawn* swamped and capsized in heavy seas.
5. Because the bilge pump was not operational, the water shipped over the gunwale was retained on deck to the detriment of the vessel’s stability.
